●廃棄物層内温度測定結果

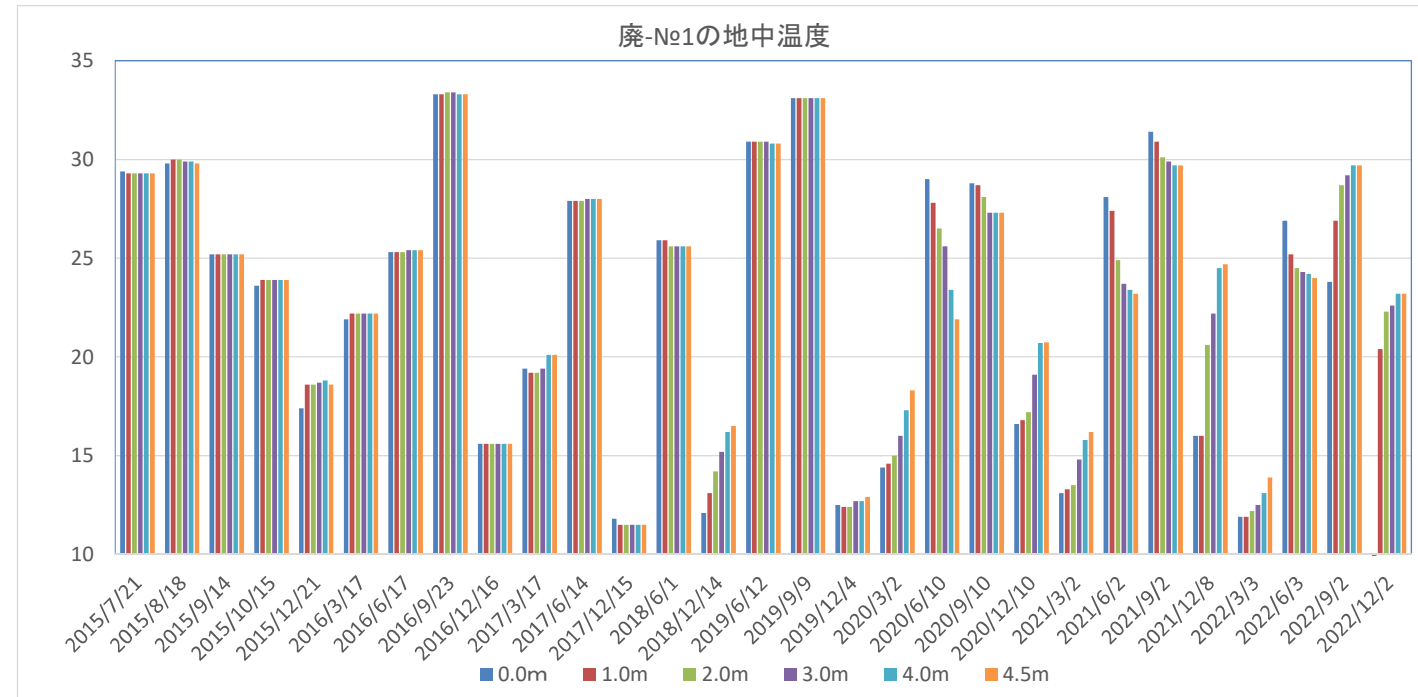
工事前	工事中	工事中	工事中	工事(中断)中	工事中	工事中	工事中	工事中	工事中	工事中	工事後	工事後	工事後	工事後	工事後	工事後	工事後	工事後	工事後	工事後	工事後	工事後	工事後	工事後	工事後	工事後		
深度	2015/7/21	2015/8/18	2015/9/14	2015/10/15	2015/12/21	2016/3/17	2016/6/17	2016/9/23	2016/12/16	2017/3/17	2017/6/14	2017/12/15	2018/6/1	2018/12/14	2019/6/12	2019/9/9	2019/12/4	2020/3/2	2020/6/10	2020/9/10	2020/12/10	2021/3/2	2021/6/2	2021/9/2	2021/12/8	2022/3/3	2022/6/3	2022/9/2	2022/12/2
